Property Inspection Report

Report Number: Sample
For The Property Located On:

123 Main Street
America

Date of Inspection: Saturday, June 6, 2020

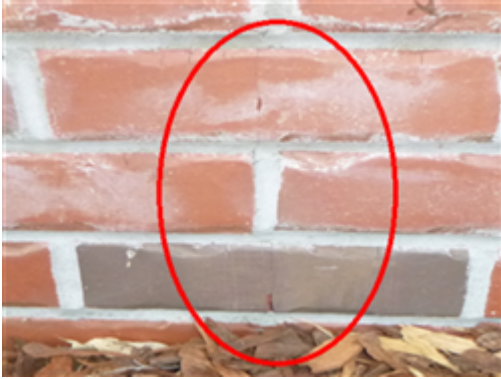
(B1 - 1.1) Main House

A crack was noted below the window in the brick veneer at the rear of the home (middle window of sun room). Cracks in brick veneer indicate a deficiency that can change or progress over the life of the home. The crack on this home was closed at the time of the inspection and presented no visible evidence of progression to the foundation areas, however, the cracks could open or change seasonally. The owners should be asked for disclosure related to the progression, history of repairs, or seasonal changes of the cracks. Even closed or minor cracks can cause consumer or buyer concerns at the time of resell. The buyers should observe the cracks and assess their concerns related to the presence of the cracks, the number of cracks, and possibility of the condition worsening over the life of the home. The cracks should be noted, and monitored to establish a history of stability.

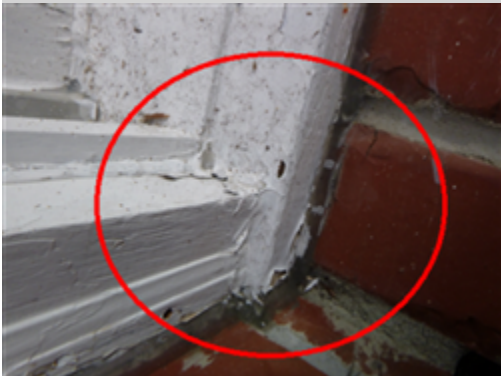
(B2 - 1.1) Windows

The garage windows have visible wood filler repairs. Wood filler is used as a temporary repair when wood decay is present. Decay in the windows can result in leaking and water penetration and should be repaired as soon as possible. Since wood filler repairs have a limited life and depend on the complete removal of all decay, the repairs need further evaluation. The homeowner should be asked for disclosure related to the age/extent of the repair and any history of leaks.

The garage windows also have missing trim which holds the single pain of glass in place. This is a safety issue because the glass pain can potentially fall out when the window is open/closed.

The garage windows also have missing trim which holds the single pane of glass in place. This is a safety issue because the glass pane can potentially fall out when the window is open/closed.

A licensed general contractor should be consulted to evaluate the extent of the damage and make necessary repairs.

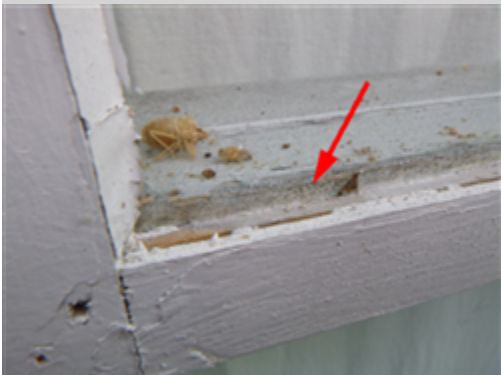
(B2 - 1.2) Windows

Additional Photograph: This is a photograph of garage windows

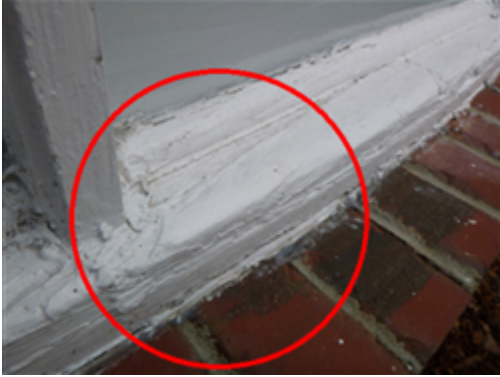
(B2 - 1.3) Windows

The Bay window at the front of the home has visible wood filler repairs. Wood filler is used as a temporary repair when wood decay is present. Decay in the windows can result in leaking and water penetration and should be repaired as soon as possible. Since wood filler repairs have a limited life and depend on the complete removal of all decay, the repairs need further evaluation. The homeowner should be asked for disclosure related to the age/extent of the repair and any history of leaks. A licensed general contractor should be consulted to evaluate the extent of the damage and make necessary repairs.

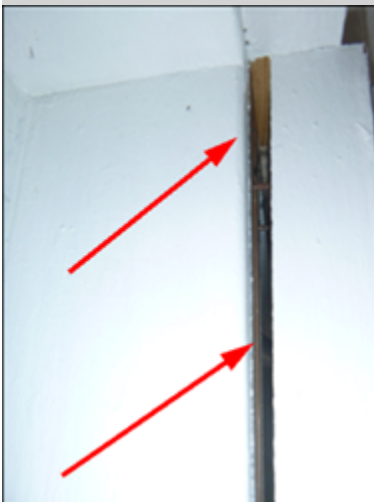
(B2 - 2.1) Door

The front door frame is pulling away from the home at the top corner. The door needs repair/replacement to ensure that the door closes securely and is weather tight. A general repair specialist or licensed general contractor should be consulted for evaluation and repair.

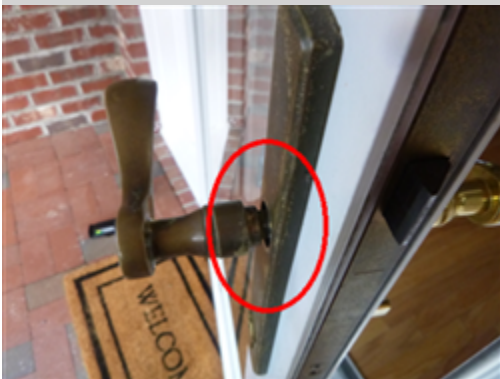
(B2 - 2.2) Door

The storm door at the front of the home is in need of repair , the doors handle was loose. Technically a storm door is not covered by the home inspection SOP, however, when the handle is loose it creates a safety issue. A repair specialist should be consulted for repair or replacement.

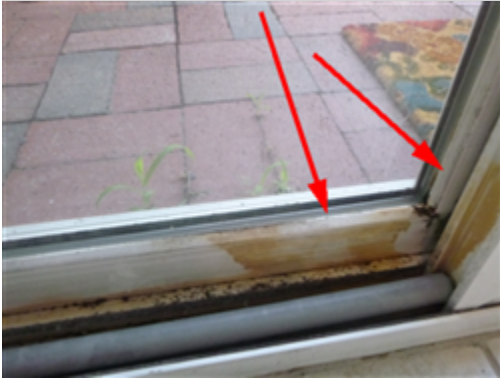
(B2 - 3.1) Door

The stains on the door frame/door wall for the sliding glass door to the patio indicate that the door leaks at the door area. Water penetration can result in hidden damage and undesirable conditions. A general repair specialist or licensed general contractor should be consulted for a complete evaluation to determine the source of the leak, to locate any related damage, and repair as needed.

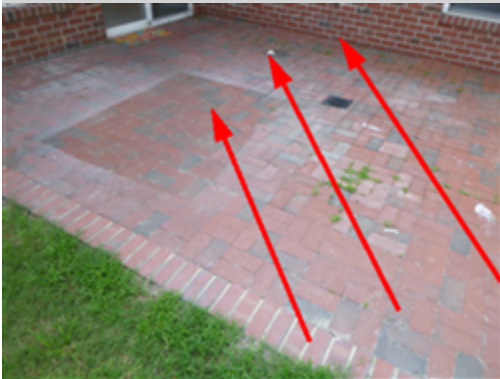
(B4 - 1.1) Patio

The patio surface is sloped to encourage storm drainage back toward the home. Drainage toward the foundation and framing areas can result in damage to the siding, doors, adjacent structural components, and allow water to enter the home resulting in undesirable conditions (see rear sliding door comment). A licensed general contractor should be consulted for further evaluation, to determine the extent of the concern, and make necessary repairs.

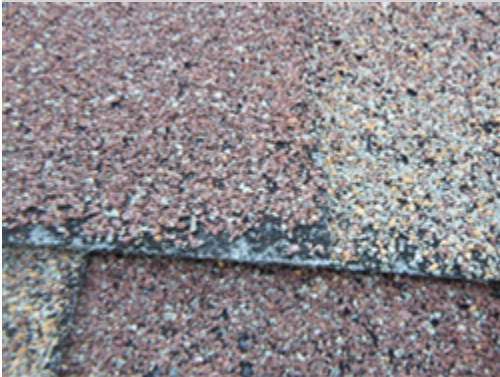
(C1 - 1.1) Main House

The shingles have visible signs of deterioration such as tab shrinkage, low ballast, and exposed base mat that indicate that they are approaching the end of their service life. Damaged shingles are in need of replacement. A licensed roofing contractor should be consulted for a complete evaluation of the roof covering and flashings system to make necessary repairs to ensure the weathertightness of the roof covering system. At the time of the repair, the roofer may be able to answer questions related to the life expectancy of the roof covering system.

The shingles have visible signs of deterioration such as tab shrinkage, low ballast, and exposed base matt that indicate that they are approaching the end of their service life. Damaged shingles are in need of replacement. A licensed roofing contractor should be consulted for a complete evaluation of the roof covering and flashings system to make necessary repairs to ensure the weathertightness of the roof covering system. At the time of the repair, the roofer may be able to answer questions related to the life expectancy of the roof covering system.

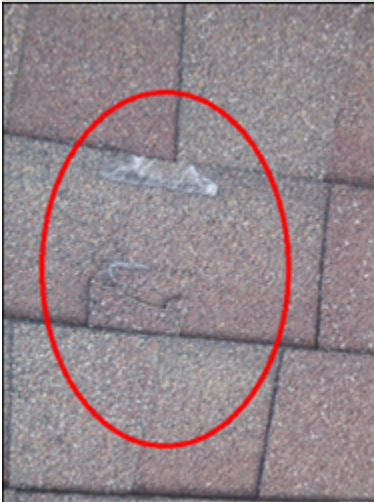
(C1 - 1.2) Main House

Additional Photograph: This is a photograph of worn shingles

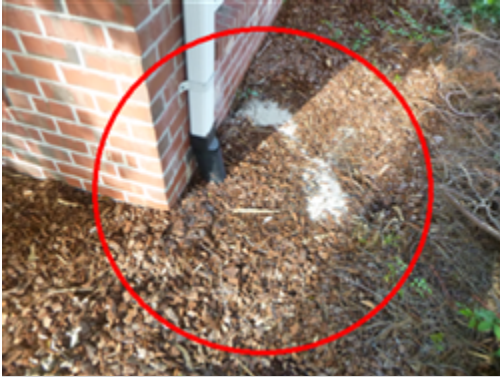
(C2 - 1.1) Main House

Evidence on the bedding and ground areas indicates that the roof drainage has been overflowing the gutter trays a the right rear of the home. Direct drainage to the foundation and cladding from the gutter system can result in water penetration into the foundation area and foundation deterioration. A licensed general contractor should be consulted for a complete evaluation of the gutter system to reduce overflow and to make necessary repairs.

Evidence on the bedding and ground areas indicates that the roof drainage has been overflowing the gutter trays at the rear of the home. Direct drainage to the foundation and cladding from the gutter system can result in water penetration into the foundation area and foundation deterioration. A licensed general contractor should be consulted for a complete evaluation of the gutter system to reduce overflow and to make necessary repairs.

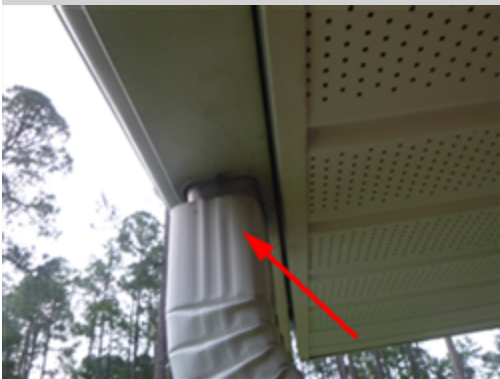
(C2 - 1.2) Main House

The downspout at the front of the home is not securely connected to the gutter. This can result in improper drainage and increases the opportunity for the downspout to become disconnected from the gutter. A licensed roofing or gutter contractor should be consulted to repair.

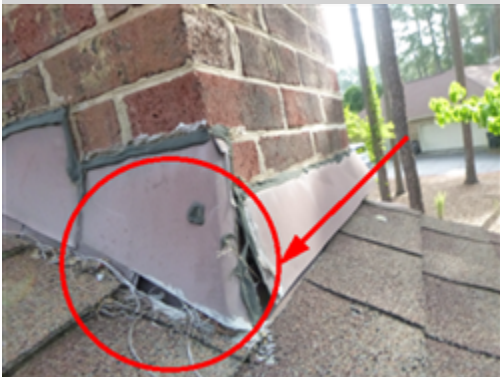
(C3 - 1.1) Main House

The flashings system around the chimney is damaged/heavily caulked. A licensed roofing contractor should be consulted for evaluation to determine the source of the leak, the extent of the damage, and repair as needed.

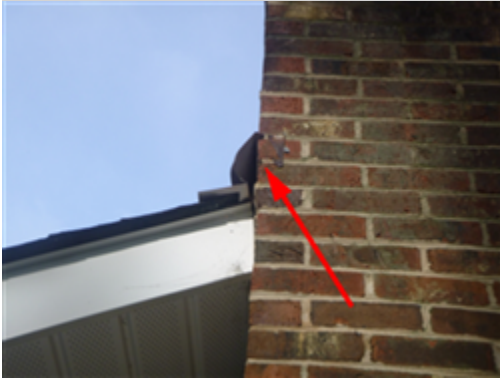
(C3 - 1.2) Main House

Additional Photograph: This is a photograph of damaged chimney flashing

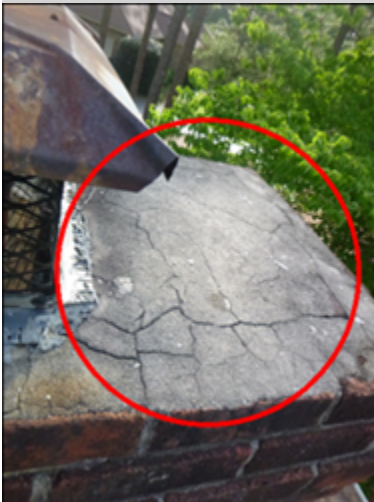
(C4 - 1.1) Main House

The mortar crown is deteriorated and cracked. When the mortar crown is damaged water can enter between the chimney body and the flue liner resulting in leaks and deterioration. A masonry contractor should be consulted for a complete evaluation of the chimney, the flue liner and the masonry crown and to make necessary repairs.

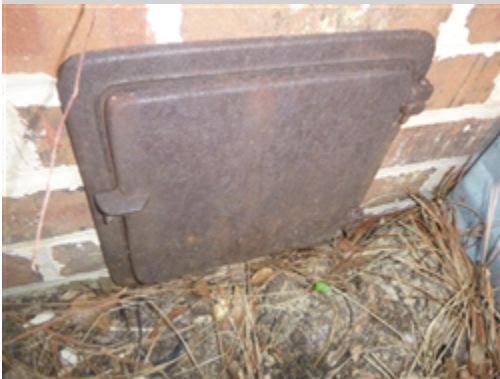
(C4 - 1.2) Main House

The fireplace cleanout door is damaged and in need of repair/replacement. The cleanout door prevents active or hot embers from entering unprotected areas. The chimney needs a complete evaluation and invasive inspection prior to use. A chimney sweep and general contractors should be consulted for a complete evaluation of the chimney and to make necessary repairs to ensure that the chimney is safe and functional.

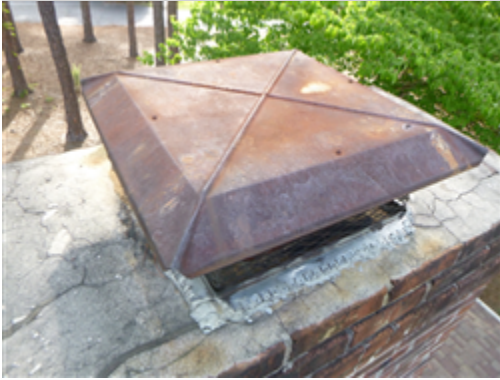
(C4 - 1.3) Main House

The chimney cap is rusted. The corrosion could indicate the age of the cap or that the cap is not properly installed. If the cap is not functioning properly it could direct drainage or moisture into the flue or roof area. A masonry contractor should be consulted for a complete evaluation of the chimney, the flue liner and the masonry crown and to make necessary repairs.

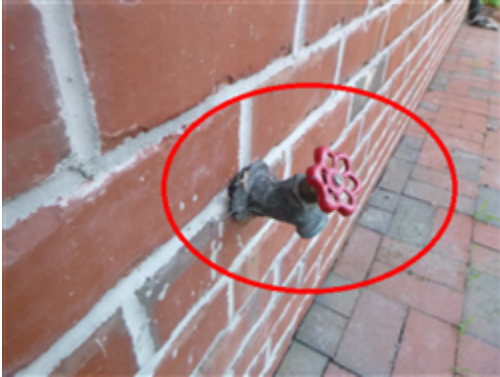
(D1 - 1.1) Exterior

The exterior faucet located at the rear of the home is not a frost free or anti siphon fixture. Although not required when this home was built, the anti-siphon faucet prevents back flow related to pressure drops to prevent contamination of the water supply and piping systems. The buyer should consider upgrading the exterior faucets.

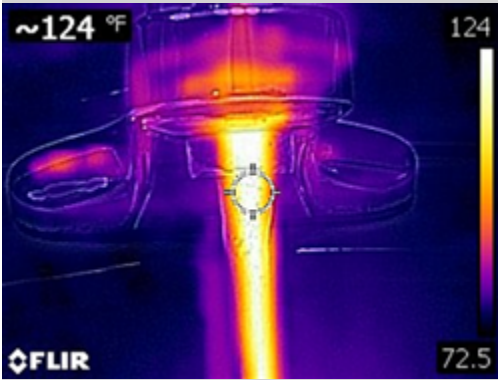
(D3 - 1.2) Unit #1

The hot water temperature for the home was noted to be too high. The recommended temperature to prevent personal injury and burns is 120 degrees F. The elevated temperature could indicate a malfunction or problems with the water heating unit. A licensed plumbing contractor should be consulted to evaluate the system to ensure that the water heating unit is operating correctly and within a safe temperature range.

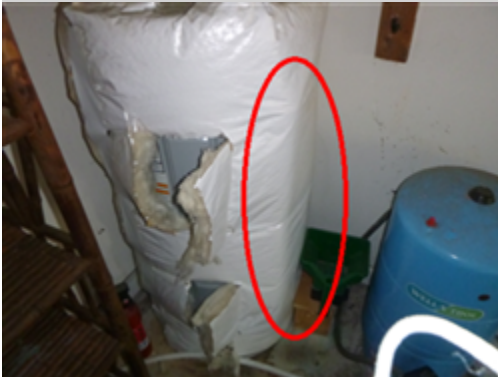
(D3 - 1.3) Unit #1

The Temperature Pressure Relief Valve (TPRV) for the water heater is a safety device to prevent the unit from exploding in case of a malfunction. The TPRV has been covered by the insulation applied around the tank. This prevents visual evidence that the TPR valve has released. A licensed plumber should be consulted to reapply the insulation around the tank where the TPRV is on the outside of the insulation.

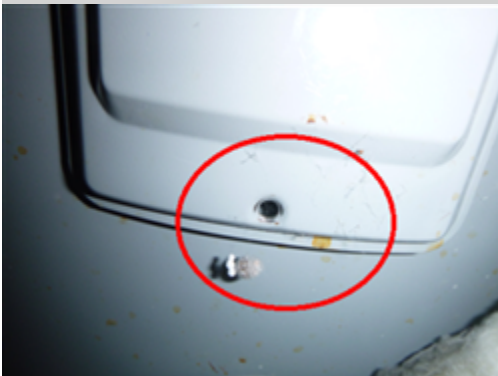
(D3 - 1.4) Unit #1

The maintenance cover panel on the hot water heater is missing screw. This could result in damage to the controls inside and also anyone who is trying to gain access. The screw should be replaced to ensure safety.

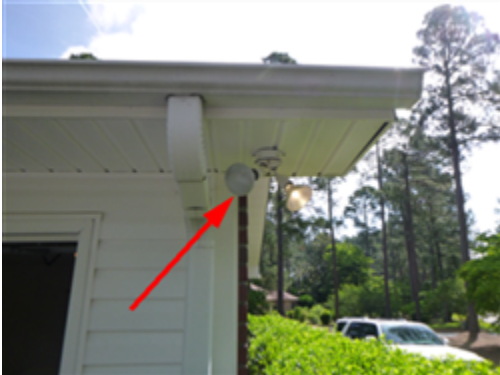
(E5 - 1.1) Exterior

The light fixture by the front left side of the home was not fully functional when tested. One of the lights on the fixture would not turn on. This could indicate a defective bulb or other more serious problem such as faulty wiring or a defective fixture. A licensed electrical contractor should be consulted for further evaluation and repair.

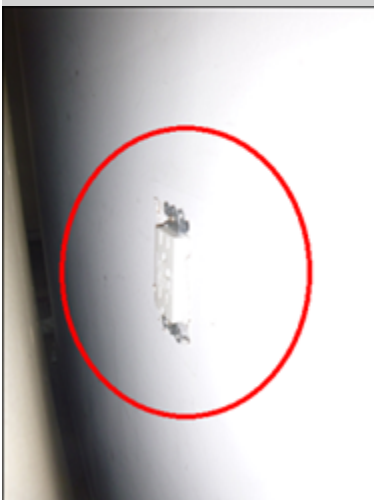
(E5 - 2.1) Garage

The receptacle in the garage (GFCI) has a missing cover plate. A missing receptacle cover plate could result in increased shock and fire hazards. A general handyman should be consulted to install a new cover plate.

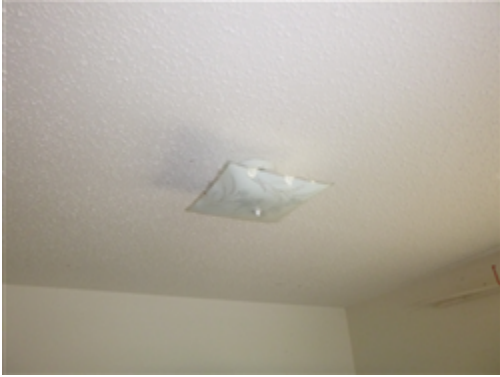
(E5 - 2.2) Garage

The light fixture to the right side inside the garage was not functional when tested. This could indicate a defective bulb or other more serious problem such as faulty wiring or a defective fixture. A licensed electrical contractor should be consulted for further evaluation and repair.

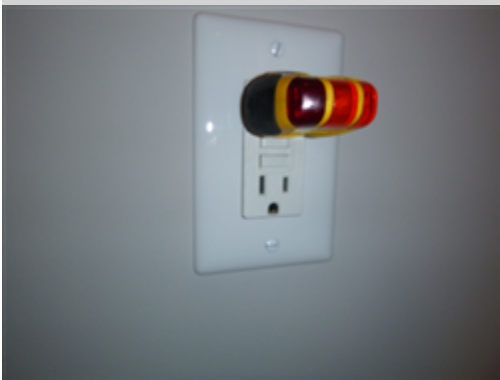
(E5 - 3.1) Master Bathroom

The GFCI receptacle for the master bathroom by the toilet did not operate properly when tested. The GFCI is an important safety feature that should be kept functional to reduce shock hazards. A licensed electrical contractor should be consulted for repair.

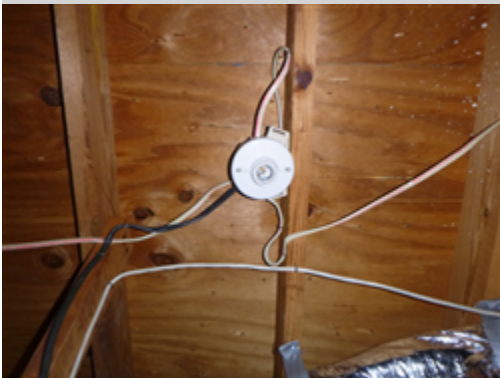
(E5 - 4.1) Attic

The light fixture at the entrance of the attic was not tested because no bulbs were present. The bulbs should be installed and the fixture verified to operate properly. A general repair specialist should be consulted.

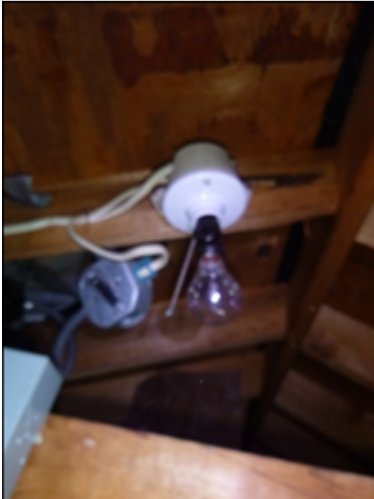
(E5 - 4.2) Attic

The light fixture in the attic by the attic ventilation fan was not functional when tested. This could indicate a defective bulb or other more serious problem such as faulty wiring or a defective fixture. A licensed electrical contractor should be consulted for further evaluation and repair.

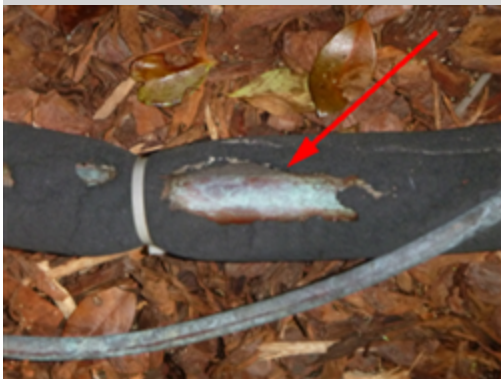
(G1 - 1.2) Cooling Unit #1

The large line of the AC refrigerant line set that connects the outside compressor unit to the interior air handler is required to be insulated to reduce condensation and associated water damage. The AC line insulation is missing/damaged at the exterior of the home. A HVAC contractor should be consulted for a complete evaluation and repair of the system to ensure reliable and proper operation of the HVAC system.

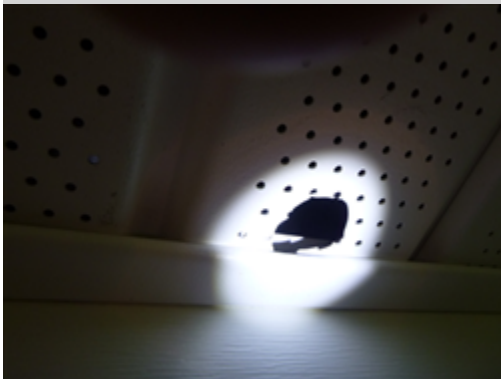
(G1 - 1.3) Cooling Unit #1

The secondary overflow which is connect to the condensate pan in the attic is not properly aligned to discharge out of the hole in the soffit vents. This cause two issues: the first is if the secondary is needed, the condensate will be draining into the attic and not out of the home and second, the hole has allowed a penetration for insects/animals to enter the attic. A licensed HVAC contractor should be consulted to repair the situation.

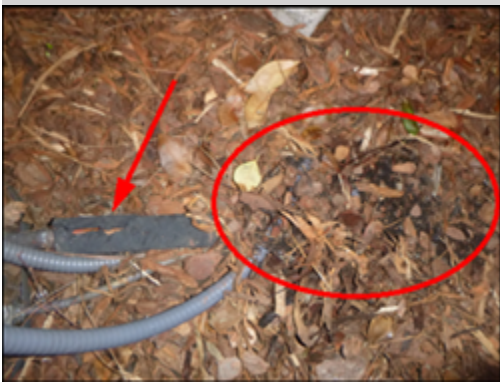
(G1 - 2.2) Cooling Unit #2

The large line of the AC refrigerant line set that connects the outside compressor unit to the interior air handler is required to be insulated to reduce condensation and associated water damage. The AC line insulation is missing/damaged and is buried under the landscaping at the exterior of the home. A HVAC contractor should be consulted for a complete evaluation and repair of the system to ensure reliable and proper operation of the HVAC system.

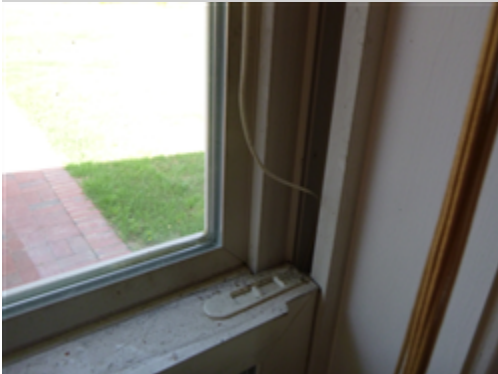
(H1 - 1.1) Sunroom

The windows in the sun room needs repair to ensure proper operation. The window could not be opened. A licensed general contractor should be consulted for evaluation and repair.
Note: The inspection of the window can not be completed when the inspector is not able to open window. When repairs are made the inspection and the window can be opened the inspection should be completed.

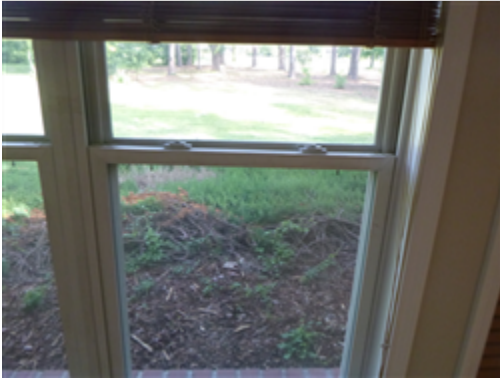
(H1 - 1.2) Sunroom

Additional Photograph: This is a photograph of stuck window in sunroom

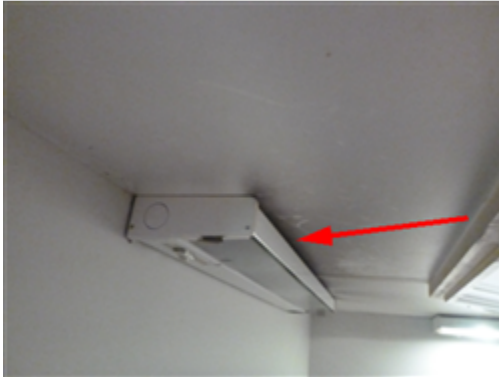
(H2 - 1.1) Kitchen

The light fixture under the cabinet by the sink in the kitchen was not functional when tested. This could indicate a defective bulb or other more serious problem, further evaluation is needed. A licensed electrical contractor should be consulted for further evaluation and repair.

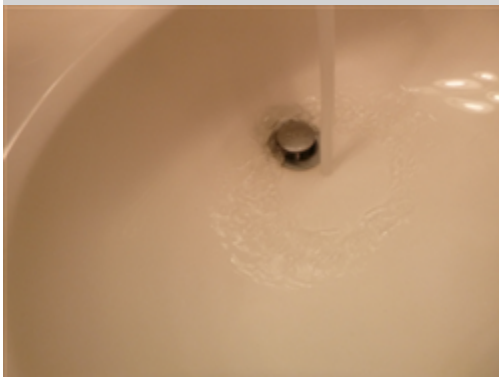
(H3 - 1.1) Bathroom: Master

In the master bathroom, the right side sink stopper did not function properly. The stopper would not stay closed when the handle was raised. This prevents the sink from filling up with water. A licensed plumber should be consulted to make necessary repairs.

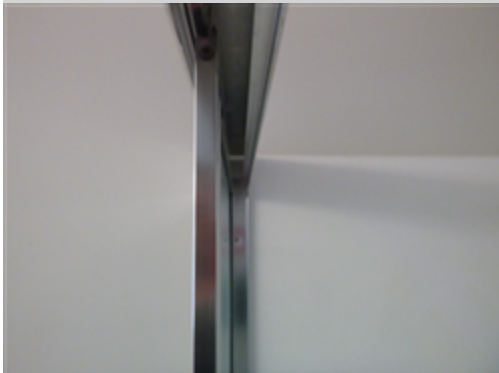
(H3 - 1.2) Bathroom: Master

In the master bathroom, one of the shower doors was missing. The shower door is important to keep water from exiting the shower when in use. A licensed general contractor should be consulted in making the repairing/replacing the door assembly to ensure it is functioning as required.

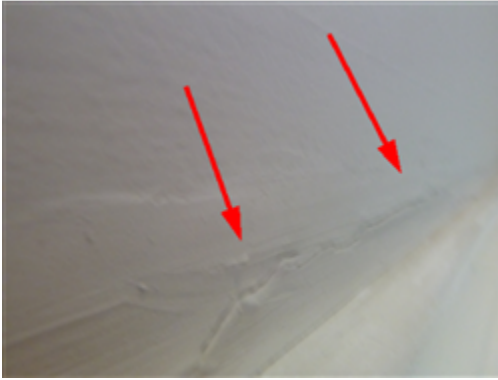
(H3 - 1.3) Bathroom: Master

Soft spots and repairs on the walls above the whirlpool indicate a history of condensation. A licensed general contractor should be consulted to review the conditions and make necessary repairs.

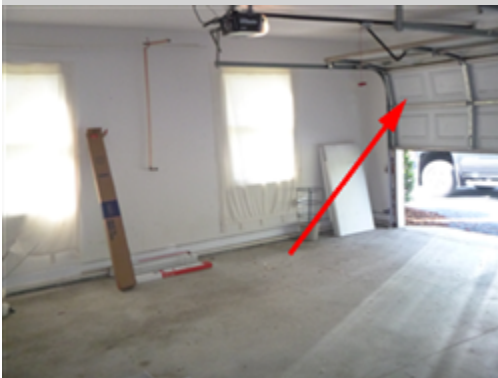
(H4 - 1.1) Garage

The right side garage door needs adjustment and repair. The door lift motor was very loud and strained as it raised and lowered the door. A garage door installation company or a licensed general contractor should be consulted for evaluation and repair to ensure that the door operates safely and properly.

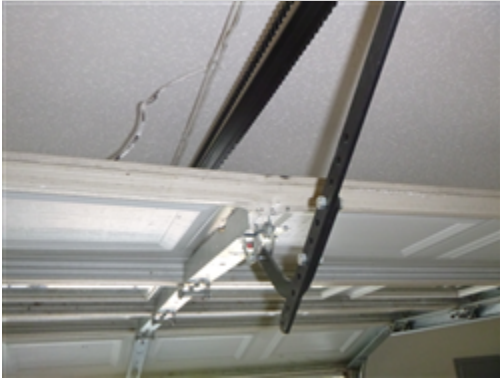
(H4 - 1.2) Garage

The garage door on the left side needs adjustment and repair. The door did not stop/reverse when the path was interrupted. A garage door installation company or a licensed general contractor should be consulted for evaluation and repair to ensure that the door operates safely and properly.

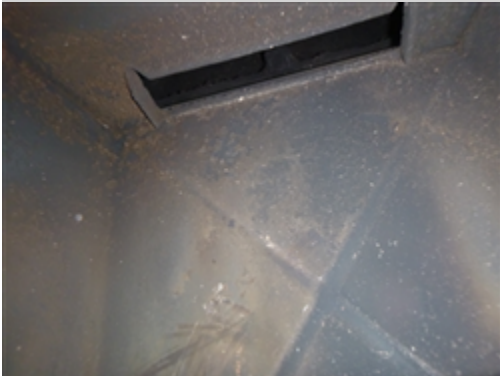
(H6 - 1.1) Fireplace Insert: Wood

From the fireplace insert opening, heavy build of creosote was noted. Creosote build-up can result in improper function of the fireplace and high potential for fire. A chimney sweep and general contractors should be consulted for a complete evaluation of the chimney and to make necessary repairs to ensure that the chimney is safe and functional.

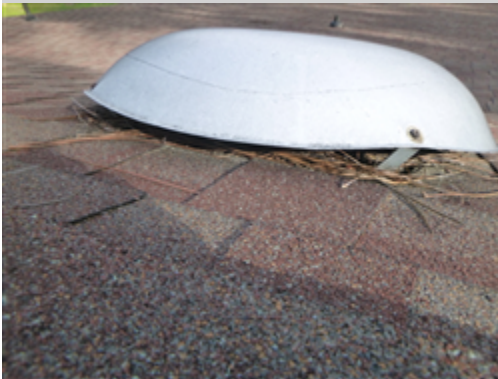
(I1 - 1.1) Attic

The inspector could not determine how to activate the attic fan. Damaged fan units can cause ventilation problems and present fire hazards. The owner should disclose how the fan is turned on and verify it operates, if not, a licensed electrician should be consulted for repair/replacement.
