Property Inspection Report

Report Number: Sample
For The Property Located On:

123 Main Street
America

Date of Inspection: Saturday, June 6, 2020

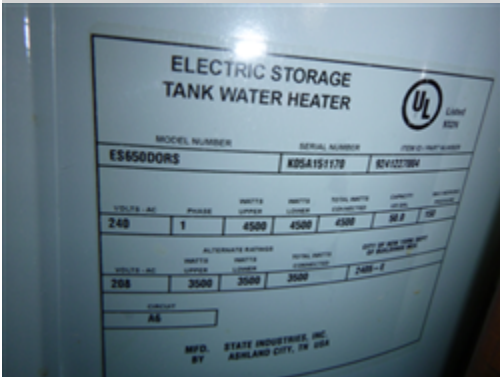
(D3 - 1.1) Unit #1

Manufacturer: State Industries (A.O. Smith)
Serial Number: K05A151170
Model Number: ES650DORS
Date: October 2005

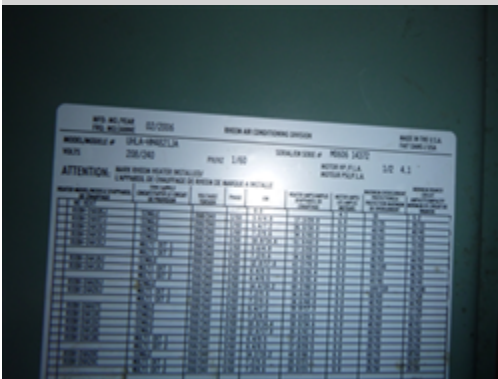
(F1 - 1.1) Heating Unit #1

Manufacturer: Rheem
Serial Number: M0607 14372
Model Number: UHLA-HM4821JA
Date: February 2006

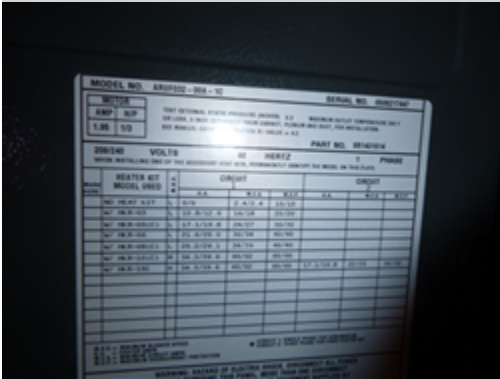
(F1 - 2.1) Heating Unit #2

Manufacturer: Goodman
Serial Number: 0508217447
Model Number: ARUF032-002-1C
Date: August 2005

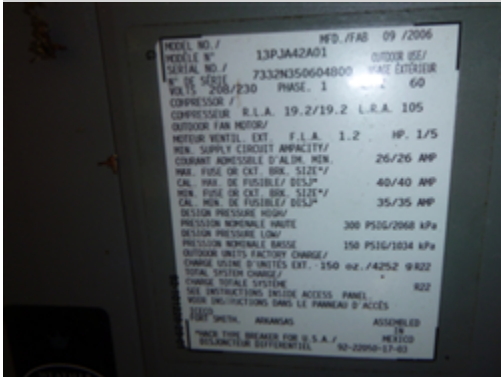
(G1 - 1.1) Cooling Unit #1

Manufacturer: Weather King (Rheem)
Serial Number: 7332N350604800
Model Number: 13PJA42A01
Tons: 3.5
Date: August 2006

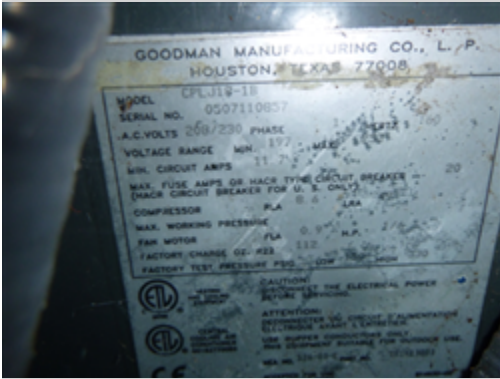
(G1 - 2.1) Cooling Unit #2

Manufacturer: Goodman
Serial Number: 0507110857
Model Number: CPLJ18-1B
Tons: 1.5
Date: July 2005
